# Flickner Innovation Farm

2.75 miles west of Moundridge, Kansas on Arrowhead Avenue

# What are we dealing with?

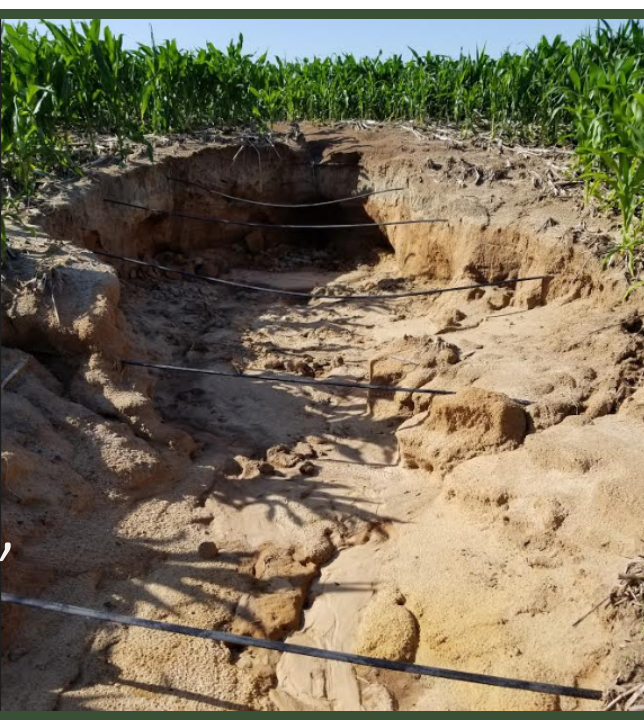
## Types of Irrigation

- Poly-pipe flood
- PMDI
- Rotor pivot
- Natural flood
- SDI on 60" and 40"

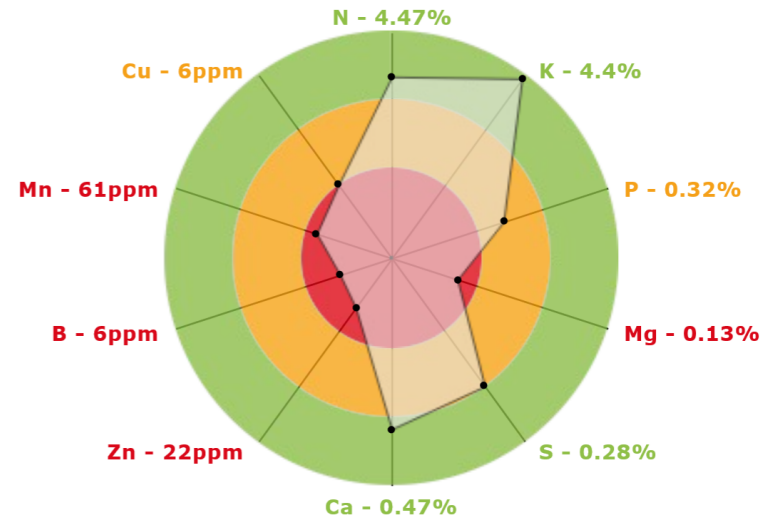
# Tissue Sampling = 6/10/2019 @ V5

Nitrogen 4.47% / N-Adequate	Manganese 61ppm / Mn-Deficient
Phosphorus 0.32% / P-Responsive	Copper 6ppm / Cu-Responsive
Potassium 4.4% / K-Adequate	
Sulfur 0.28% / S-Adequate	
Boron 6ppm / B-Deficient	
Zinc 22ppm / Zn-Deficient	
Magnesium 0.13% / Mg-Deficient	
Calcium 0.47% / Ca-Adequate

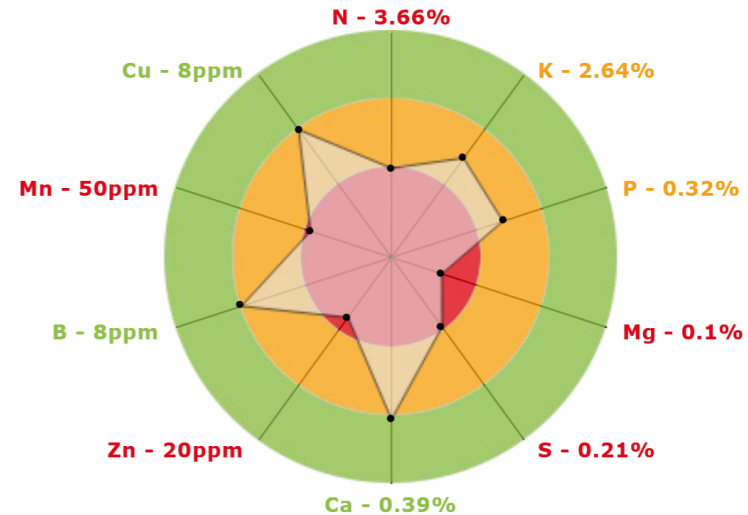
# Tissue Sampling = 6/25/2019 @ V10

Nitrogen 3.66% / N-Deficient	Manganese 50ppm / Mn-Deficient
Phosphorus 0.32% / P-Responsive	Copper 8ppm / Cu-Adequate
Potassium 2.64% / K-Responsive	
Sulfur 0.21% / S-Deficient	
Boron 8ppm / B-Adequate	
Zinc 20ppm / Zn-Deficient	
Magnesium 0.1% / Mg-Deficient	
Calcium 0.39% / Ca-Adequate

Note: The closer results are to the center of the graph, the more deficient the nutrient.

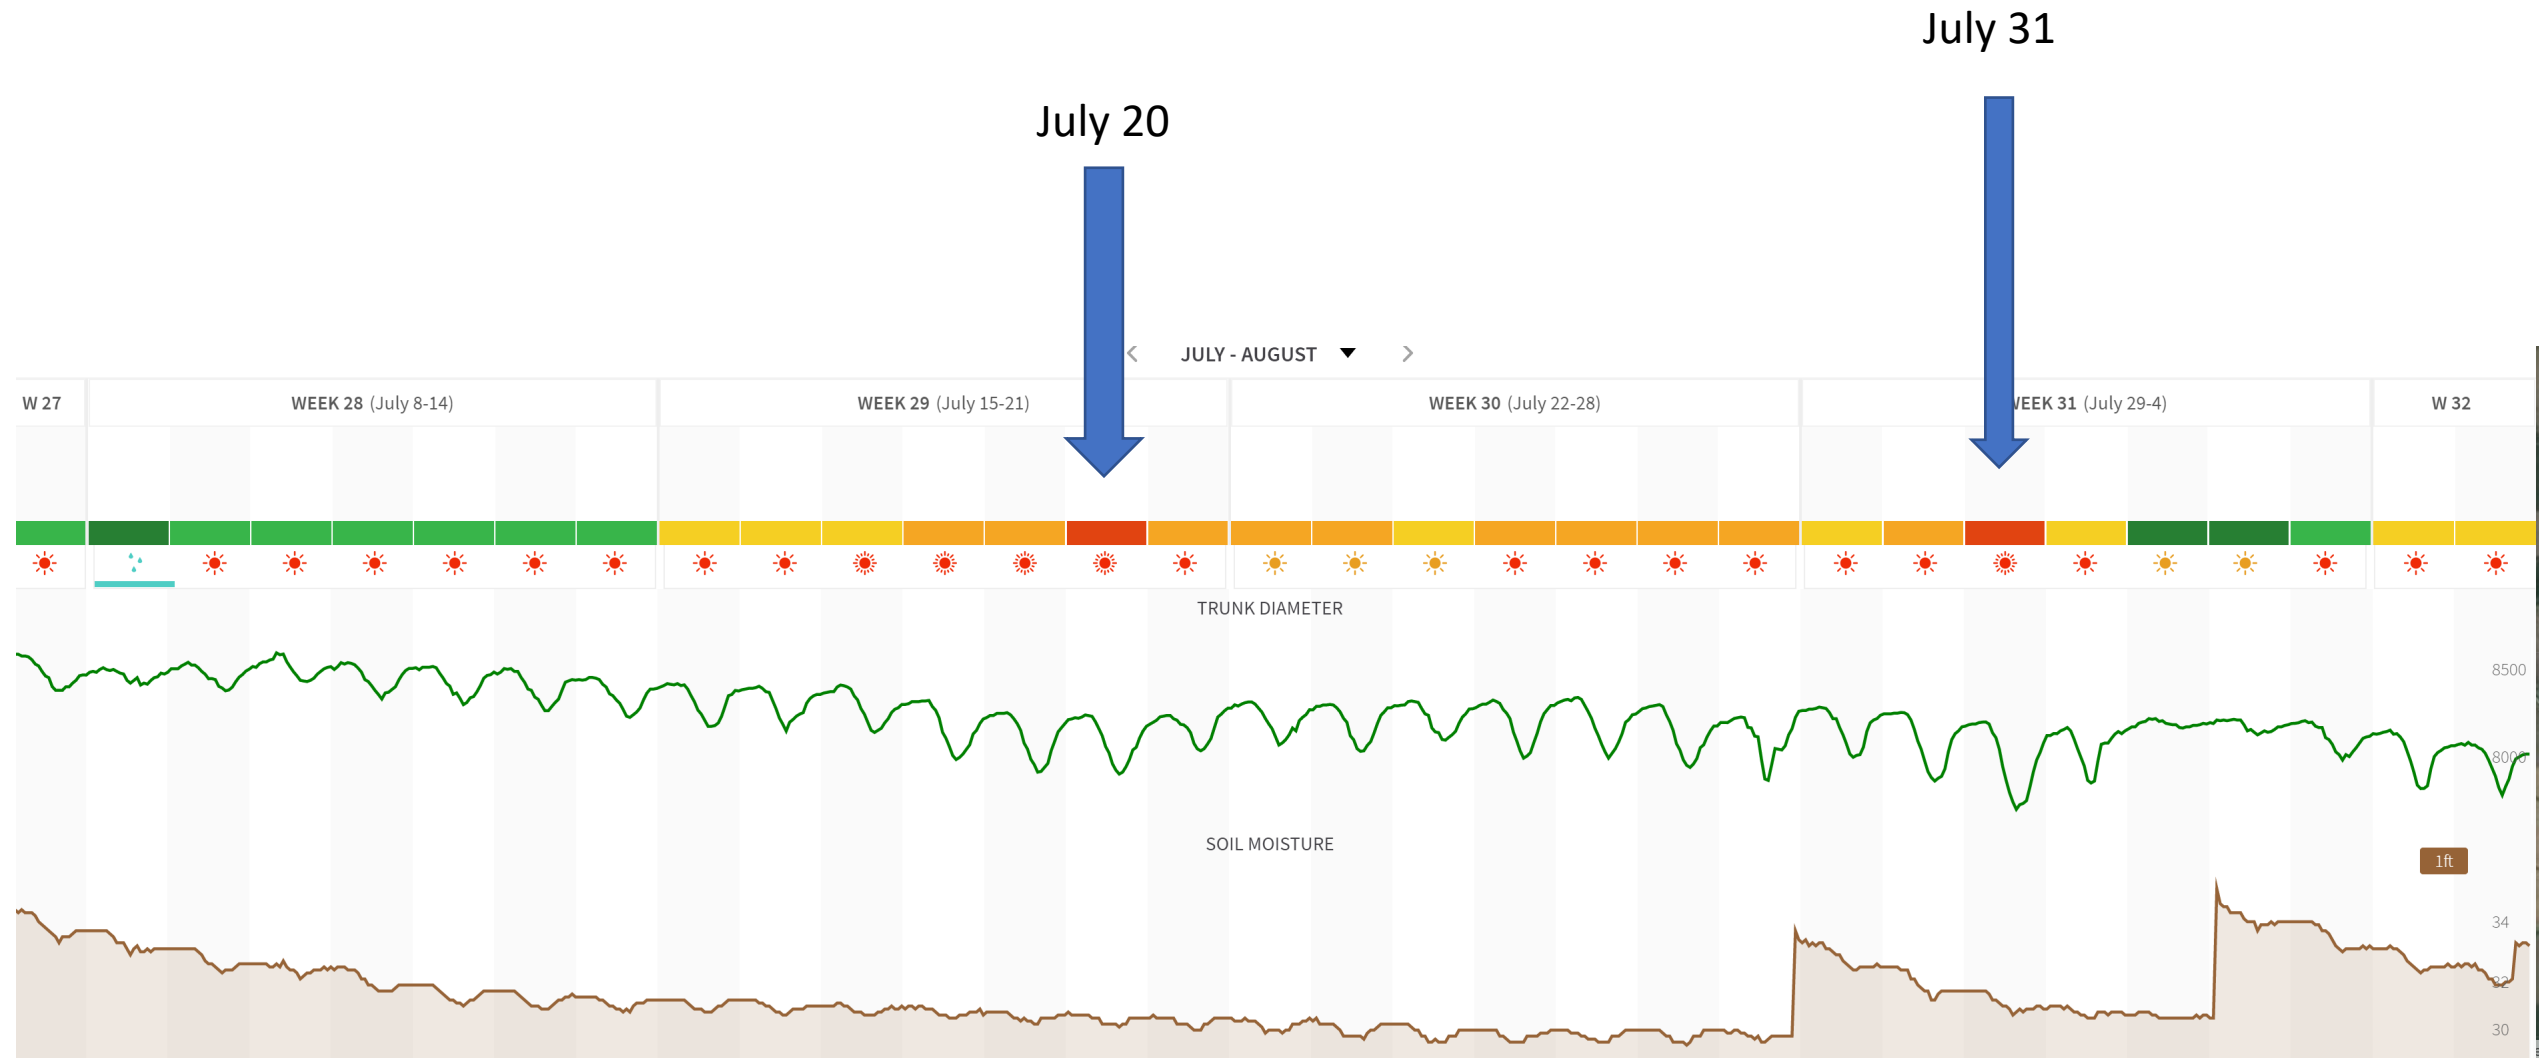
# Phytech – Home place SDI

Growing° Days: 611.2  
 Last Irrigation/Rain: 08/14/2019 (44")  
 Days to Refill: 9.0  
 Root Depth: 48"

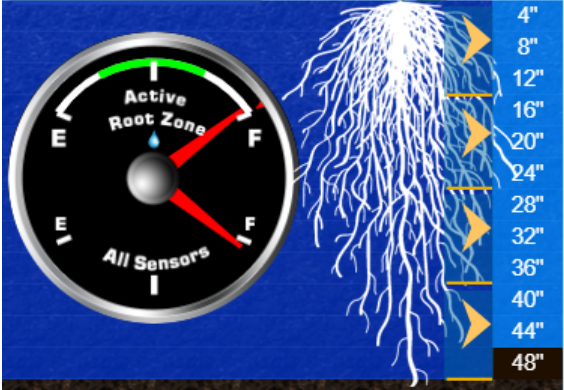
Raymond Flickner - Home Drip - Corn '19

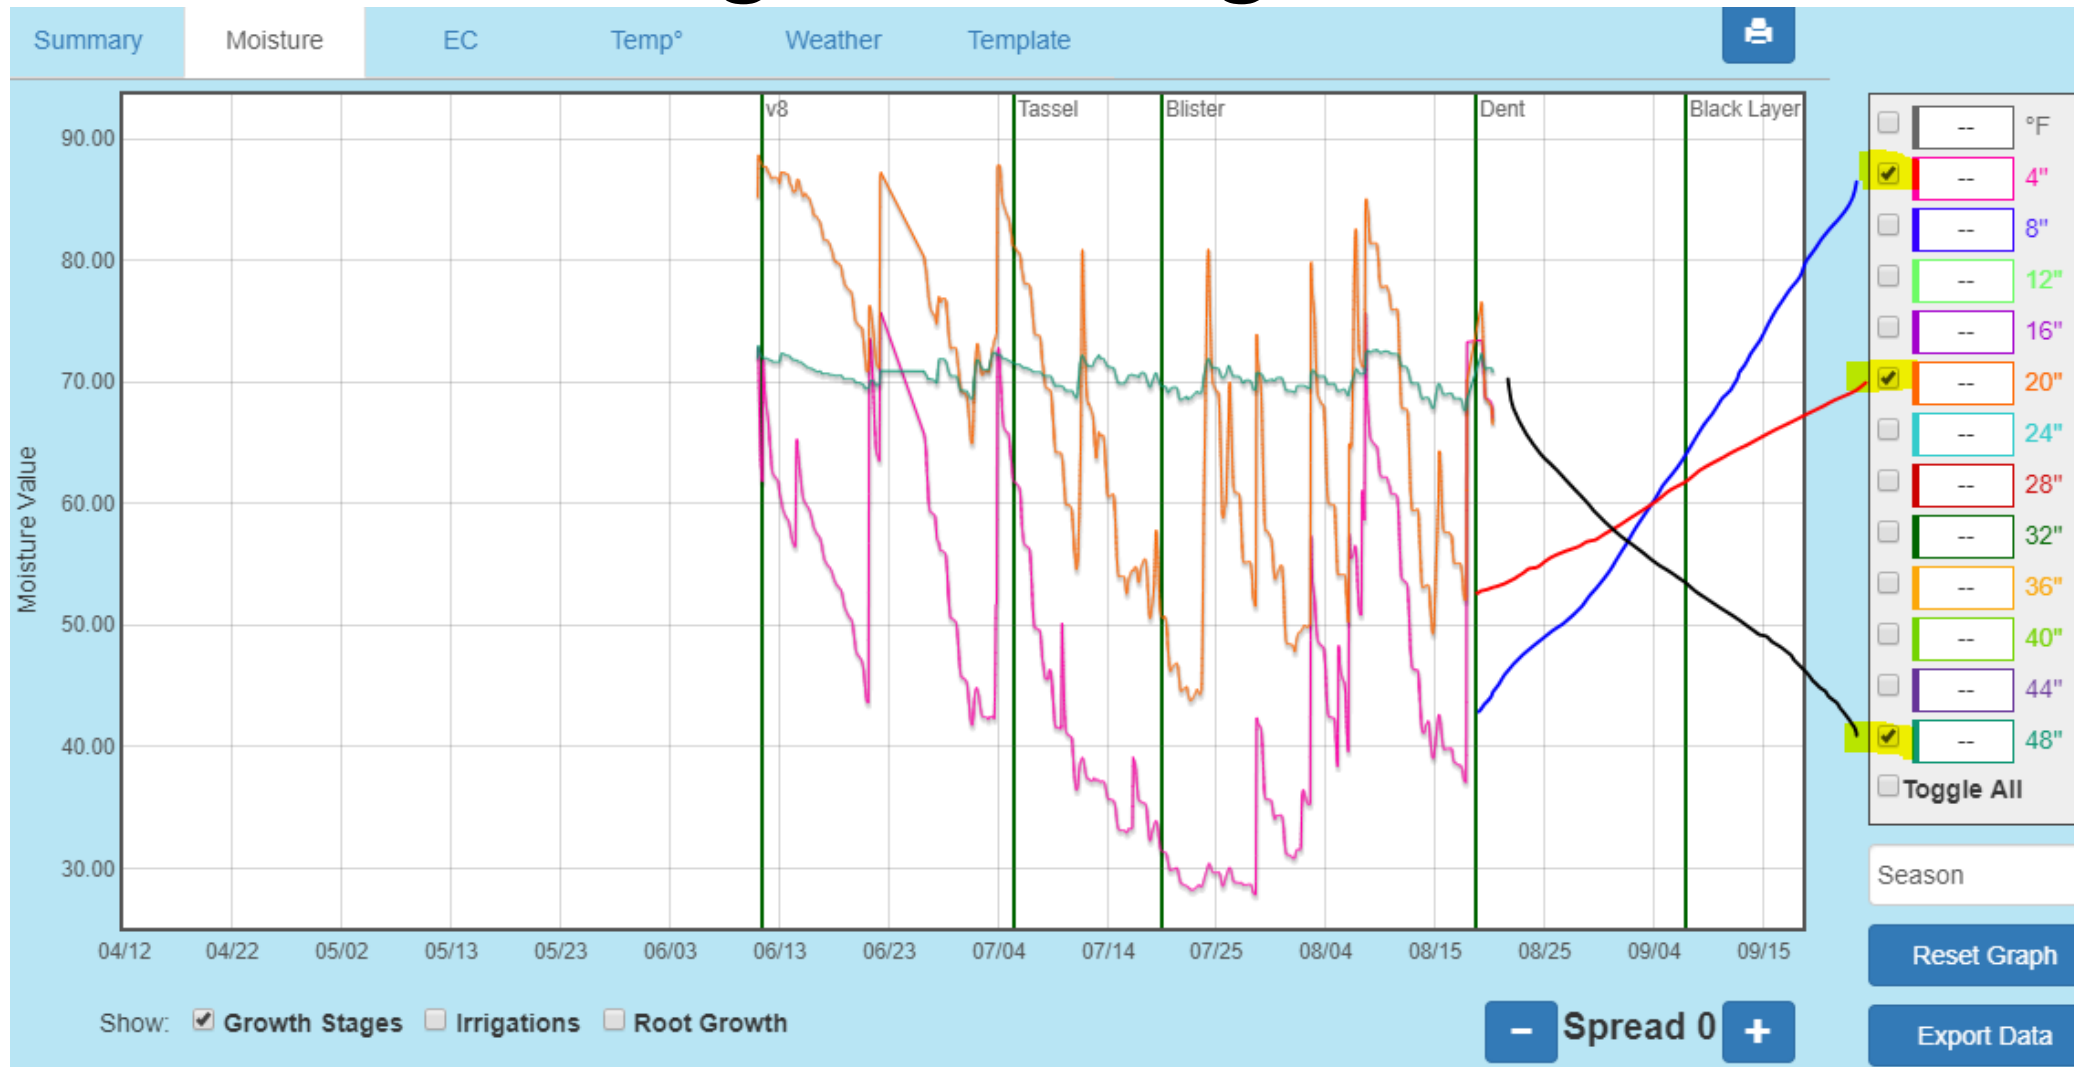
# AquaSpy – moisture levels at 4", 20", 48"; growth stages

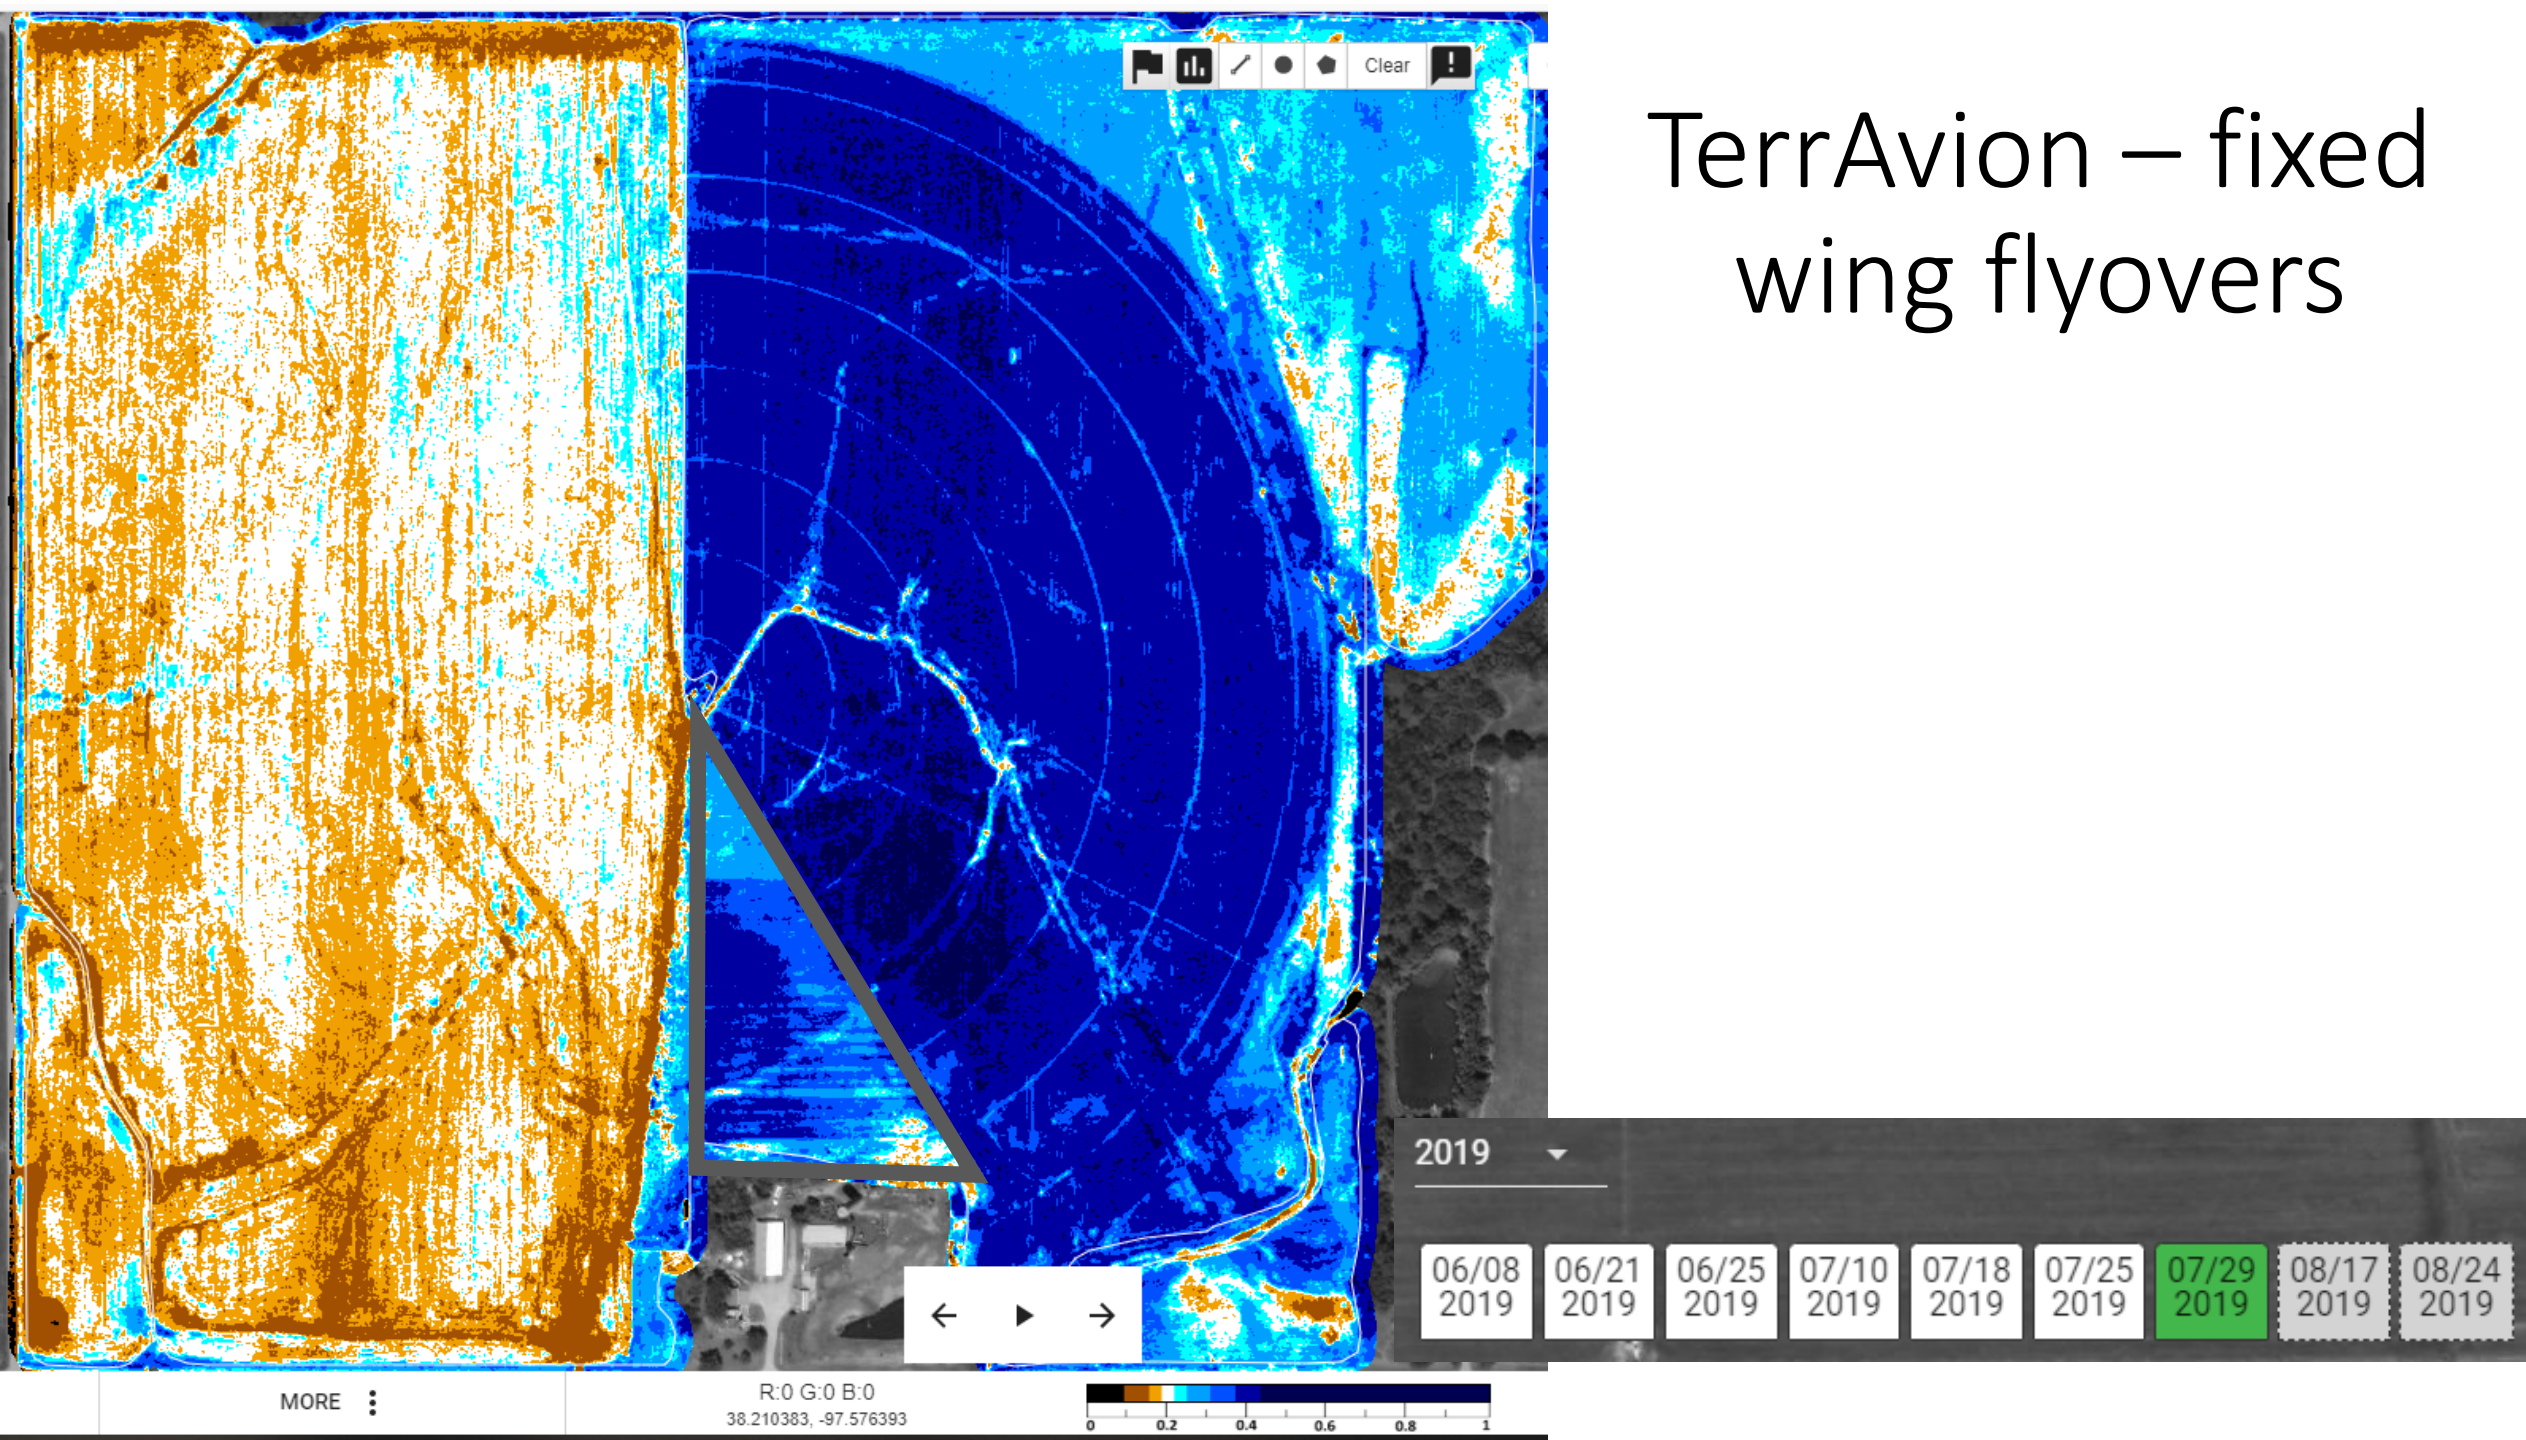
# TerrAvion – fixed wing flyovers

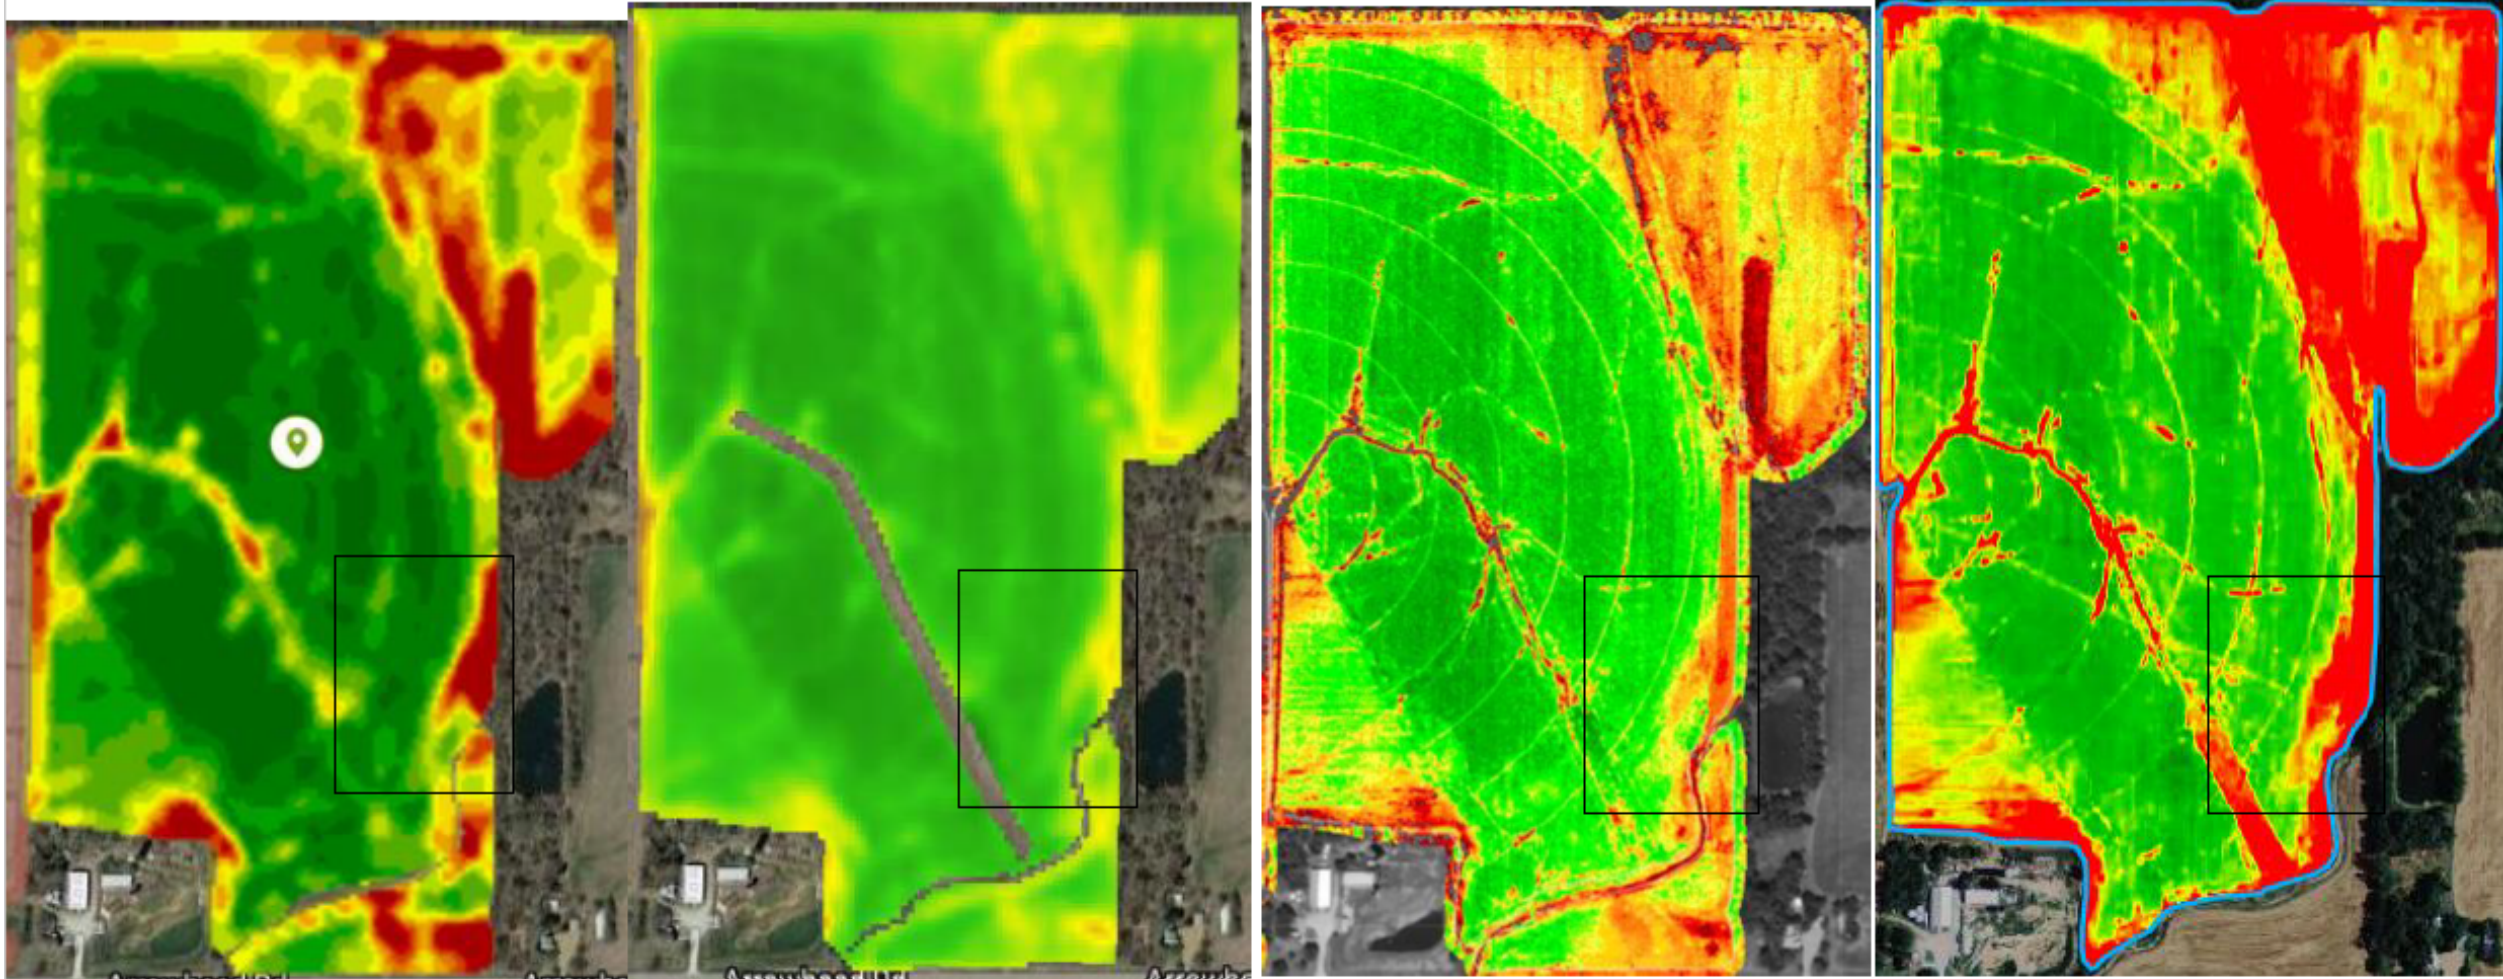
# Imagery comparison = R7, ClimateView, Terravion, American Robotics

R7  
7/19/2019

Climate  
7/19/2019

Terravion  
7/18/2019

American Robotics  
7/16/2019

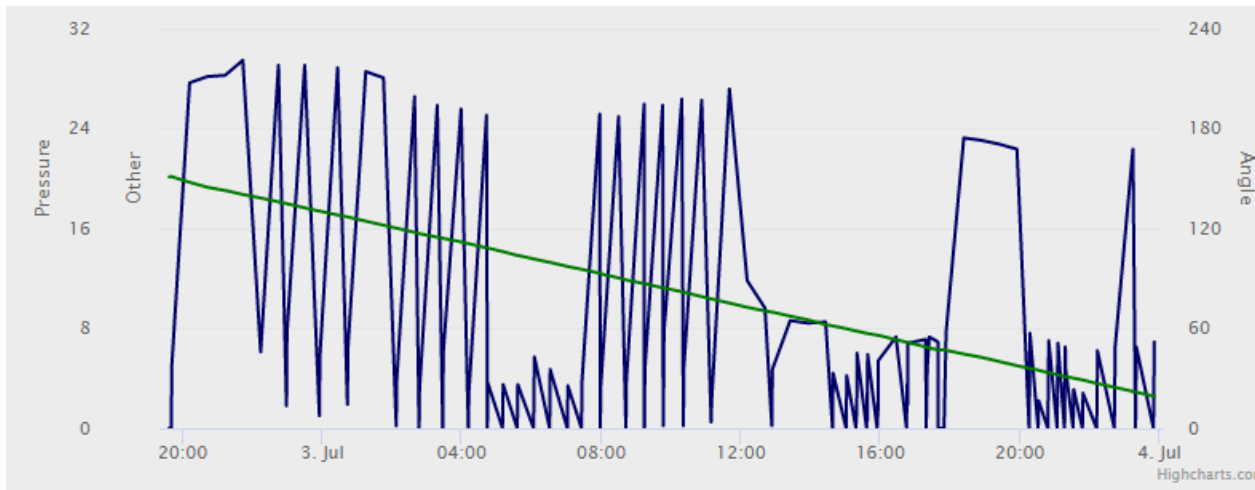
Time	Bat	Pres (psi)	Angle
08/17/19 07:42:50	4.21	21.9	222.3
08/17/19 07:12:15	4.21	21.6	224.7
08/17/19 06:41:44	4.2	21.6	227.8
08/17/19 06:11:08	4.2	21.6	230.5
08/17/19 05:40:35	4.21	21.9	233.5
08/17/19 05:10:13	4.21	22.1	236.2
08/17/19 04:39:37	4.21	22.2	239.1
08/17/19 04:09:11	4.2	22.3	241.9
	4.1	22.2	244.9
	4.1	22.1	248
	4.1	22.1	250.7

Last Reading: 08/17/2019 07:42:50  
 Current Cycle: 1 d, 21 h, 52 m  
 Full Revolution: 42 h, 21 m  
 Remaining Revolution: 2 h, 10 m  
 Est. Gallons Used YTD: 8876850  
 Yearly Allotment: 0  
 Est. Acre Inches YTD: 3.34

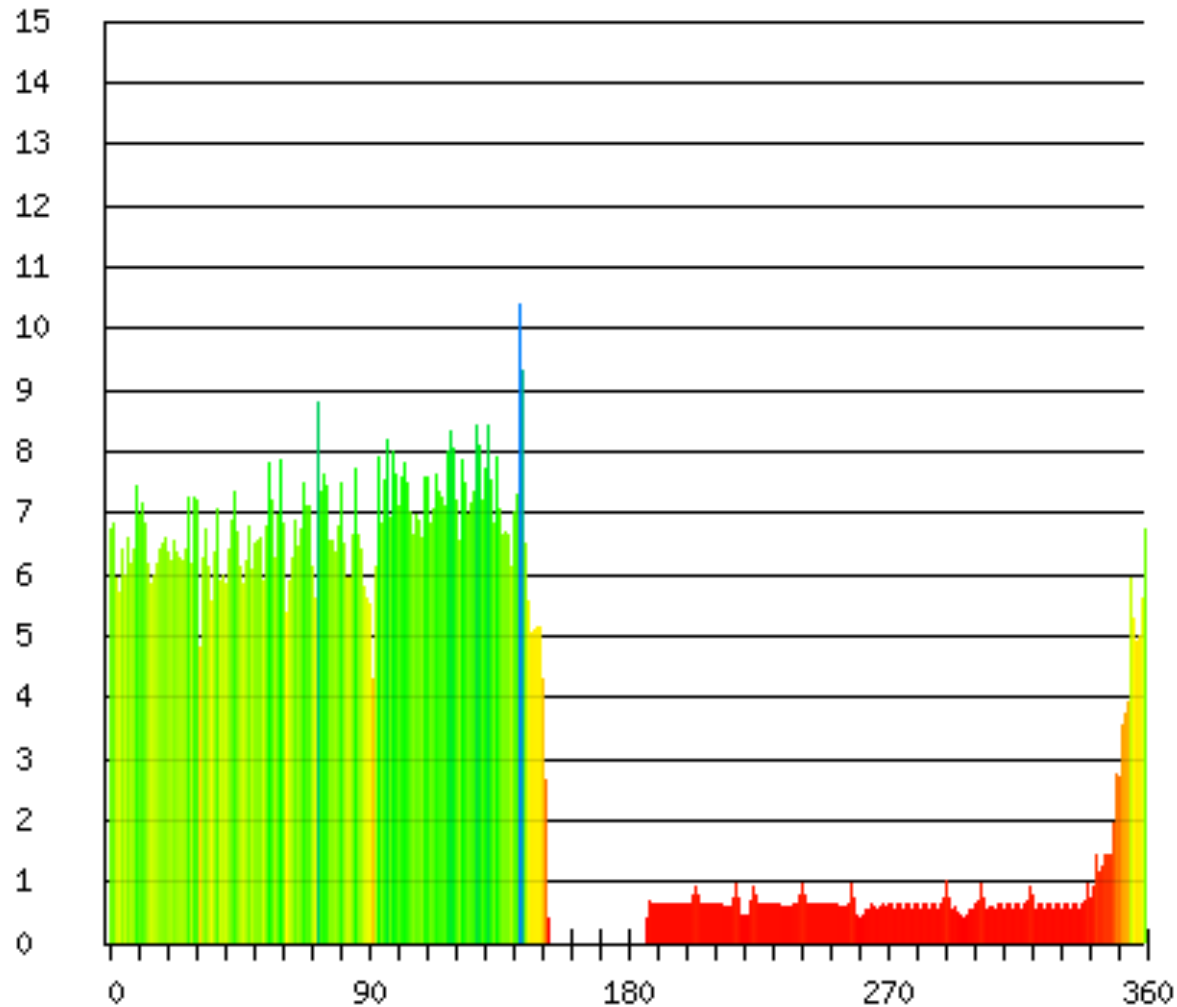
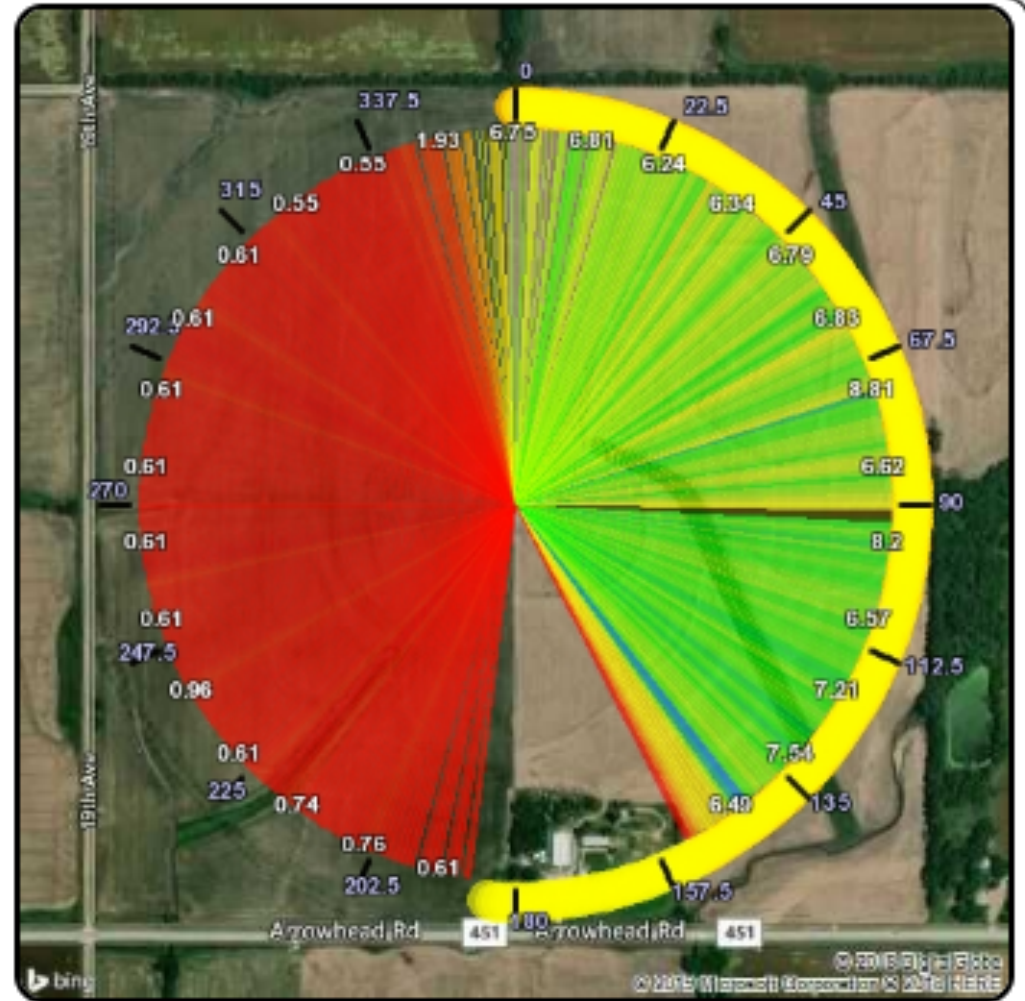
## Inches Applied by Angle

May 16, 2019 12:00 AM - Aug 20, 2019 11:59 PM - Report Type: Inches Applied by Angle

Total Inches Applied
